Diagnosis of Seismic Vulnerability in Residential Buildings in the Parroquias Pedro Carbo and Rocafuerte, Guayaquil, Applying the FEMA P-154 Methodology

Franklin Parra*
Maria Elena Vargas*
Adalberto Vizconde*
Andrés Villamar*
Gladys Castro*

Parra, F., et., Al. (2025) Diagnosis of Seismic Vulnerability in Residential Buildings in the Parroquias Pedro Carbo and Rocafuerte, Guayaquil, Applying the FEMA P-154 Methodology. *Espiraless Revista Multidisciplinaria de investigación científica*, 9 (1), 54-68

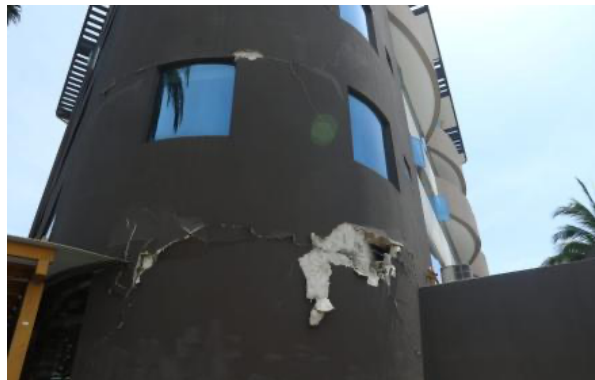
Figure 1. Building in Guayaquil affected by strong earthquake on March 6, 2023.

This figure shows the damage caused in Guayaquil after the earthquake that occurred in Pedernales on April 16, 2016.

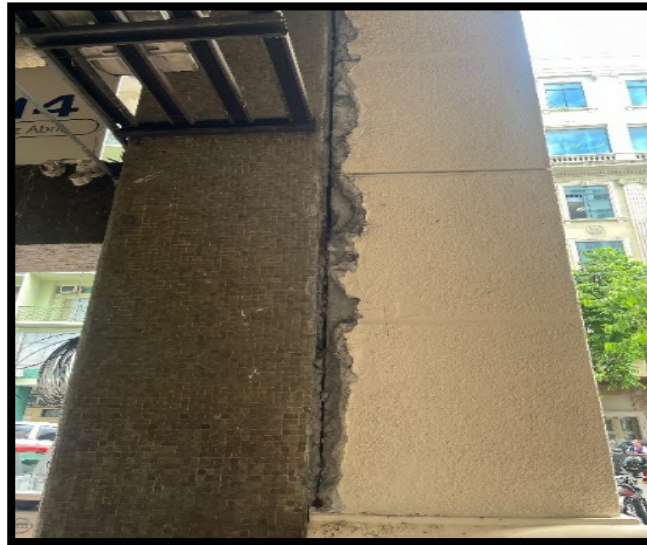
Figure 4. Visual inspection of the Aminco Amaya building, where structural damage was identified
